FINAL REPORT AUGUST 2000

REPORT NO. 98-09

M3A1 HYUNDAI CONTAINER ROLL-IN/ROLL-OUT PLATFORM (CROP) TP-94-01, Transportability Testing Procedures

REPORT NO. 98-09
M3A1 HYUNDAI CONTAINER ROLL-IN/ROLL-OUT
PLATFORM (CROP)
TP-94-01, Transportability Testing Procedures

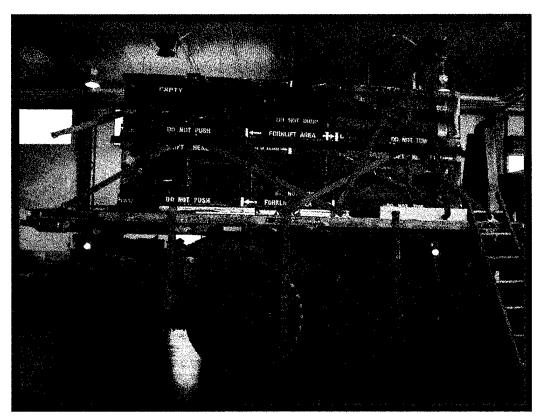
Specimen Load: MLRS on PLS trailer and chained to flatcar.

Remarks: No problems with the CROP and/or load.

Photo No. 4. MLRS pods on the CROP on the PLS trailer
